1986 Shadow (CFM aircraft #K19) TTAF = 720 hrs approx

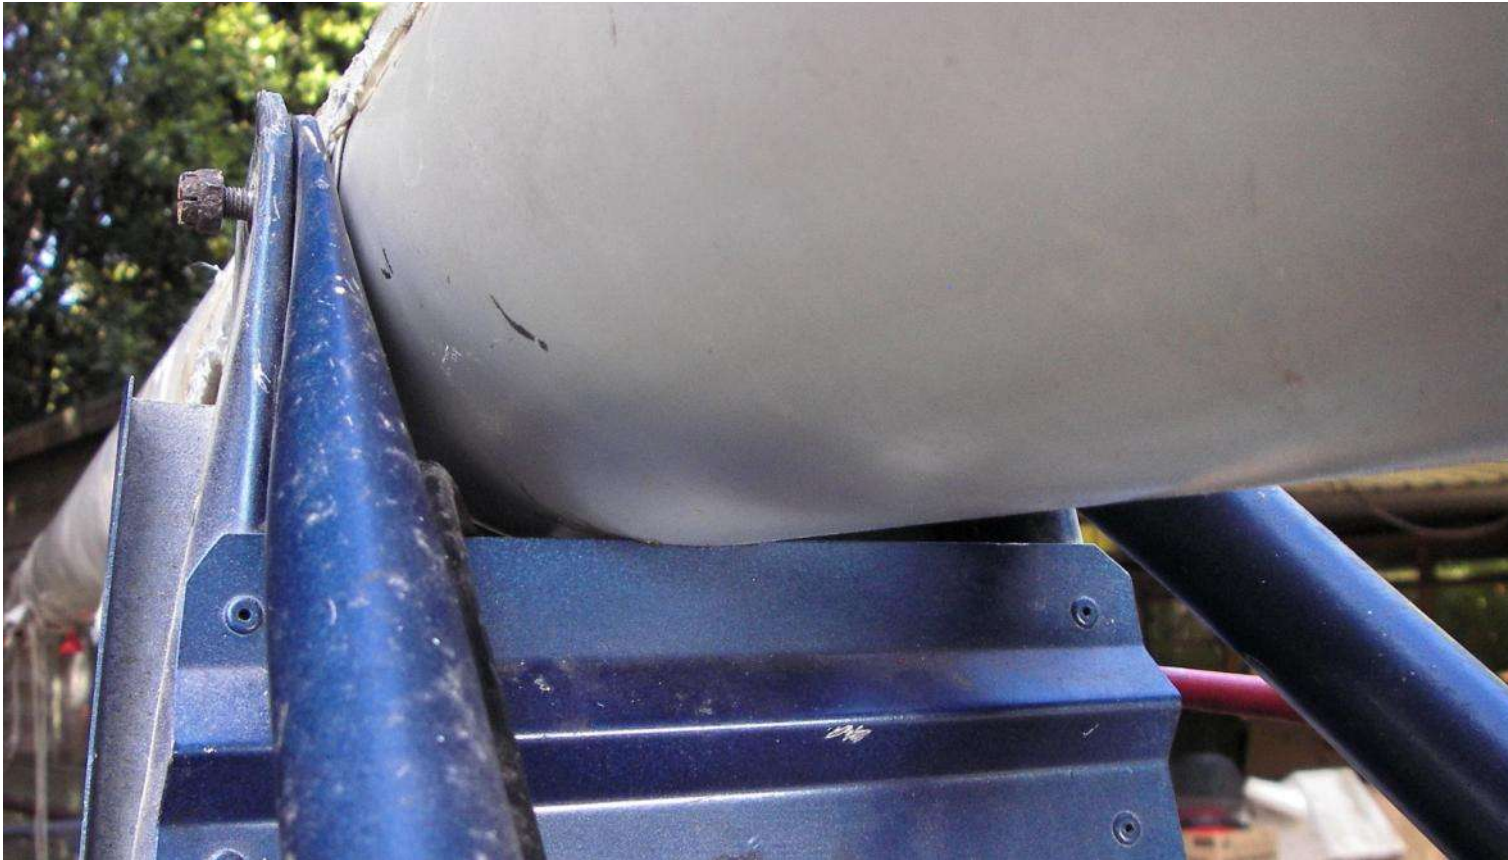
- Boom was resting on the alloy gusset (F178) that ties the two rear hanger tubes together. *[see Photo 1]*
- Tail end of the boom could be moved up and down about 45mm without lifting the fuselage.
- Tip of prop blade was nearly touching the underside of wing.
- A 25mm long groove has been worn into the underside of the boom by the alloy gusset. *[see Photo 2]*

Photo 1 View of rear hanger attachment, with boom resting on alloy gusset.

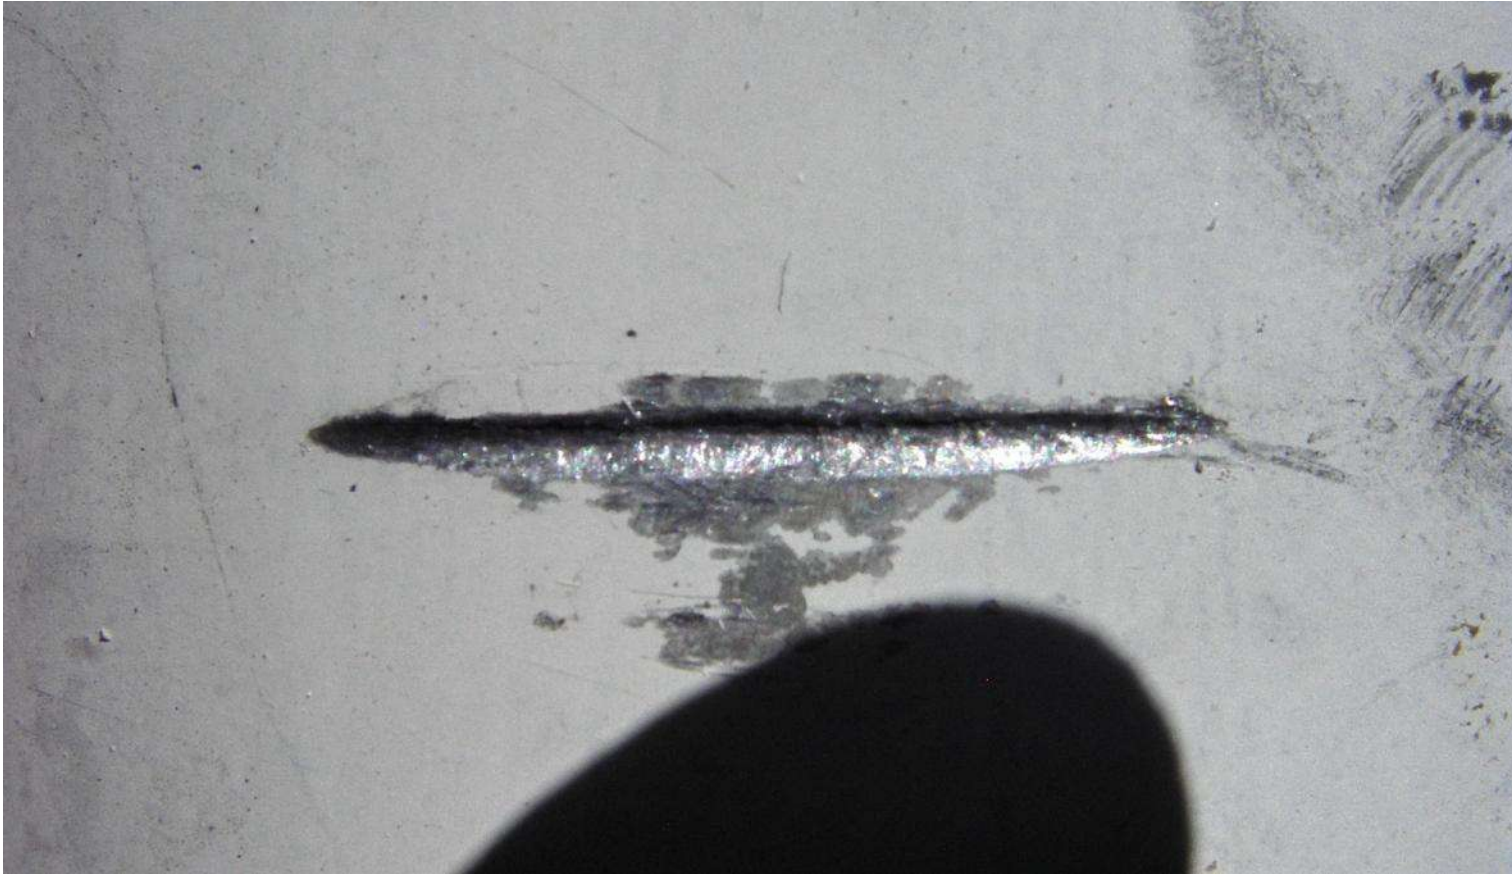
Photo 2 Groove across underside of boom (25mm long x 0.6mm deep) worn by the rear hanger gusset

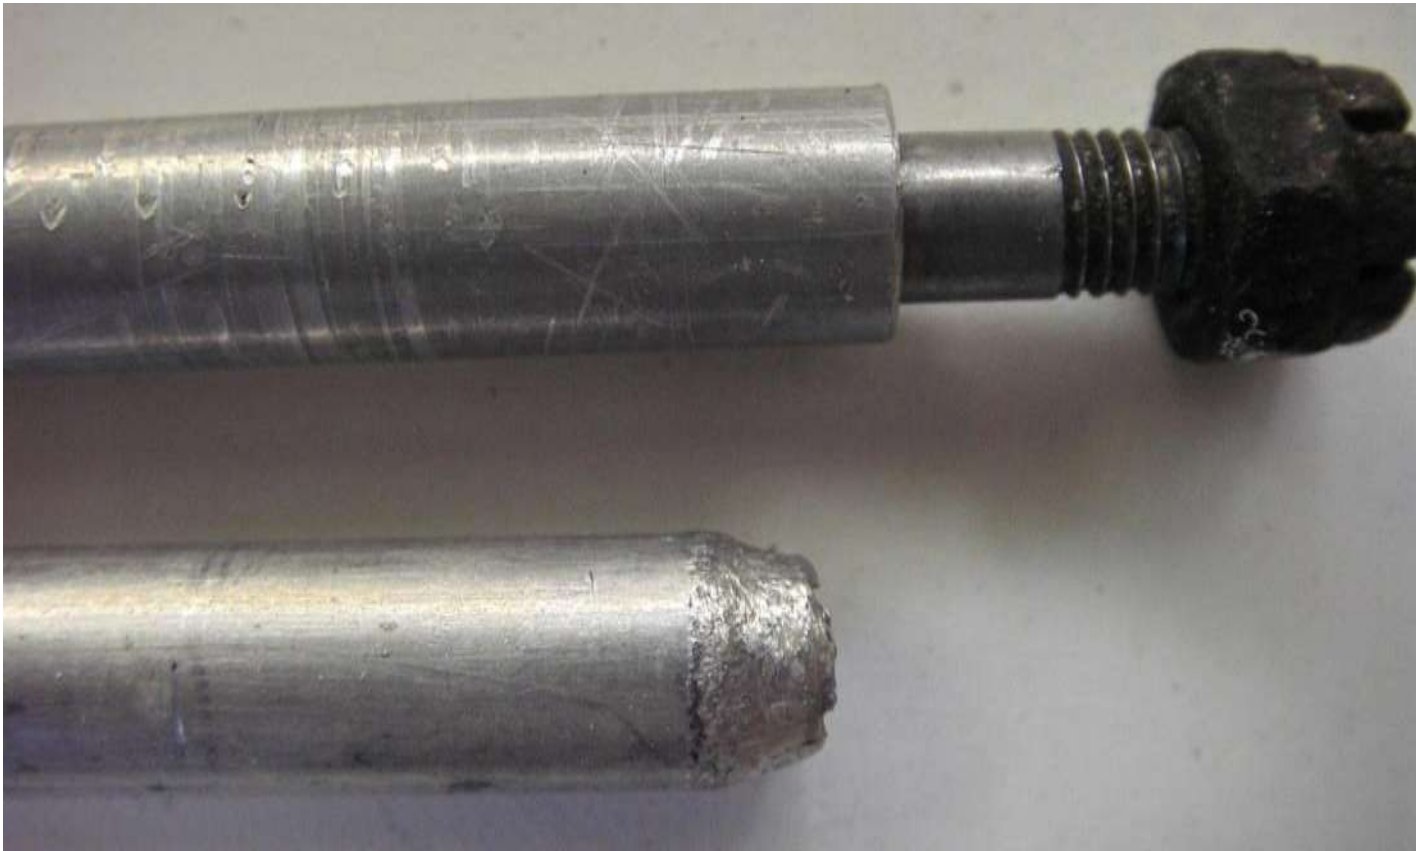
The alloy spacer tube (F144) inside the boom was too short to span the gap between hanger tubes (by at least 3 mm). This alloy spacer was very worn at both ends. [see Photo 3 + Photo 4]

Photo 3 Rear hanger thru-stud, showing worn starboard end of under-length alloy spacer (compare with new full-length spacer at top)

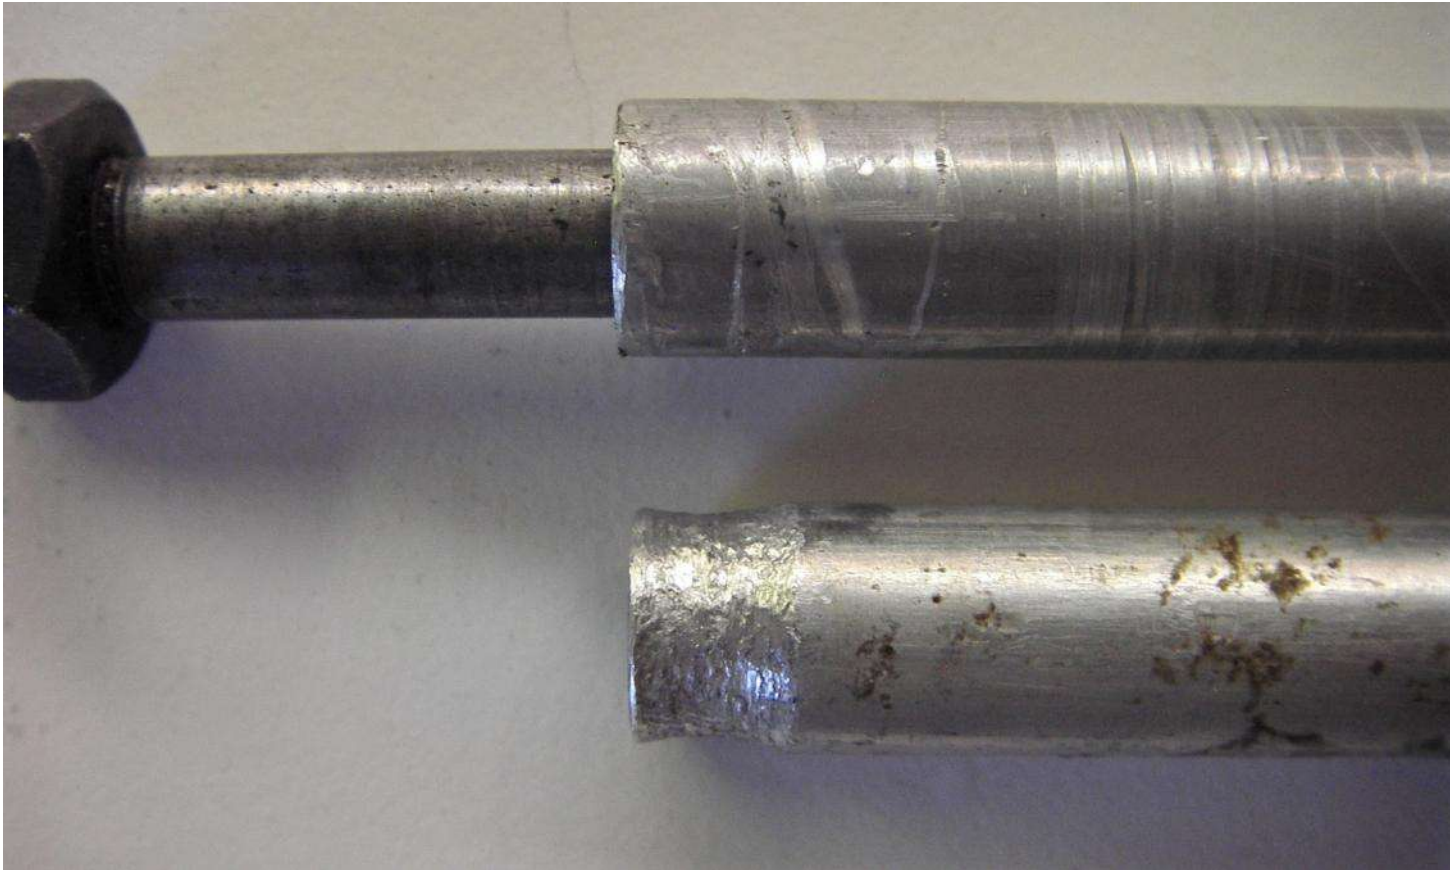
Photo 4 Rear hanger thru-stud, showing worn port end of alloy spacer (compare with new spacer at top)

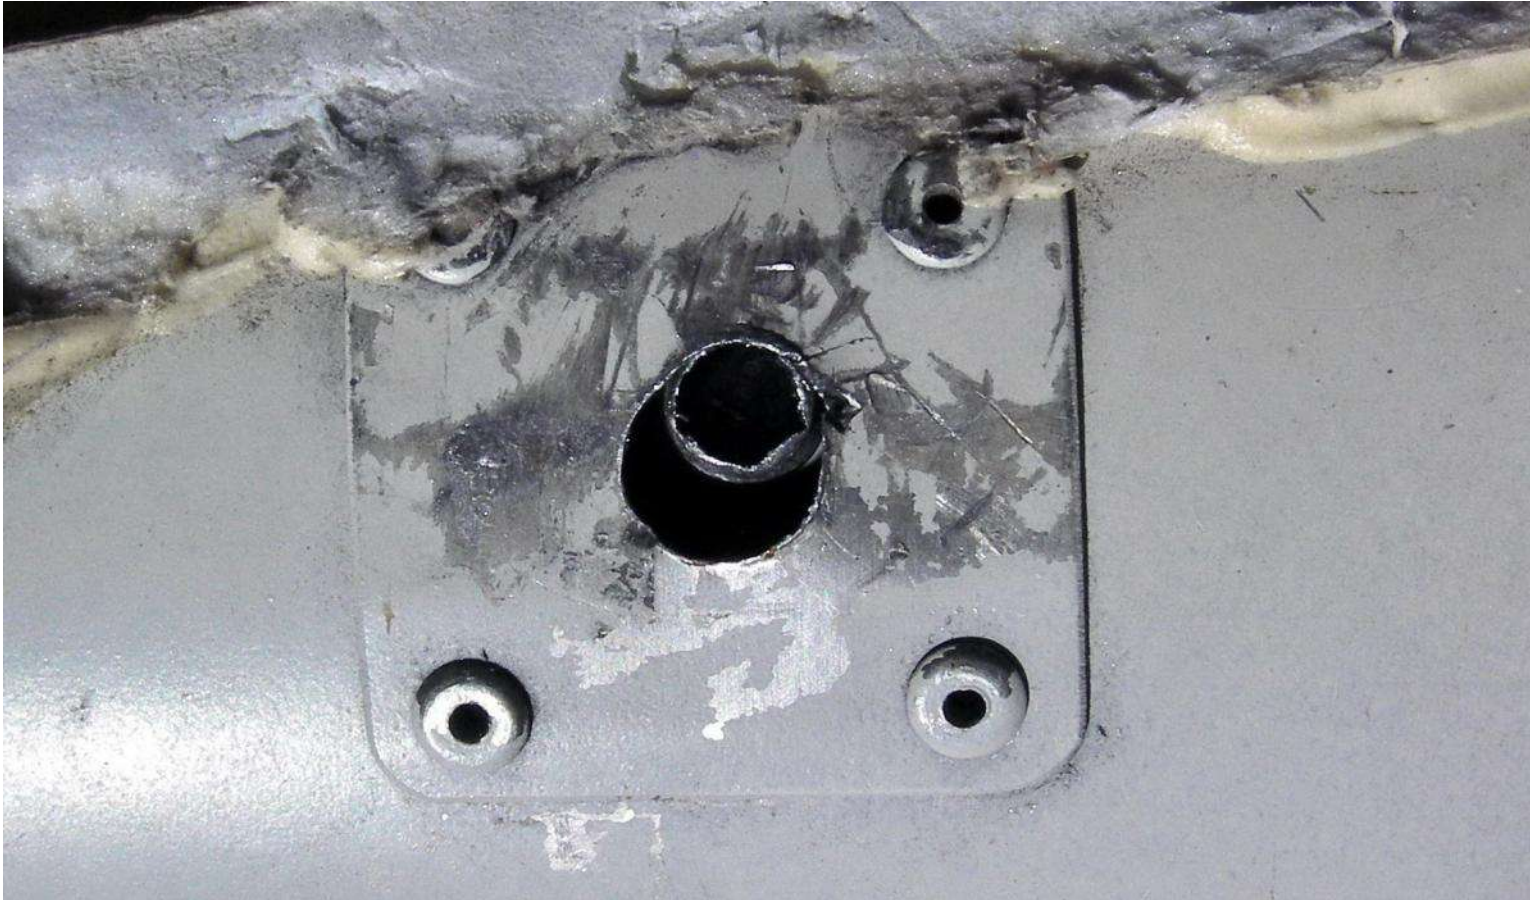
The attachment holes in the boom wall and alloy backing plates (F217) were very worn. [see *Photo 5 + Photo 6*] Both sides had very ovalised holes with about 5mm slop.

The starboard backing plate was only 1mm thick, while the port backing plate was 2mm thick.

Photo 5 Starboard side of boom at rear hanger attachment, showing at least 5.0mm ovalised wear (note under-length alloy spacer tube and 1mm thick backing plate)

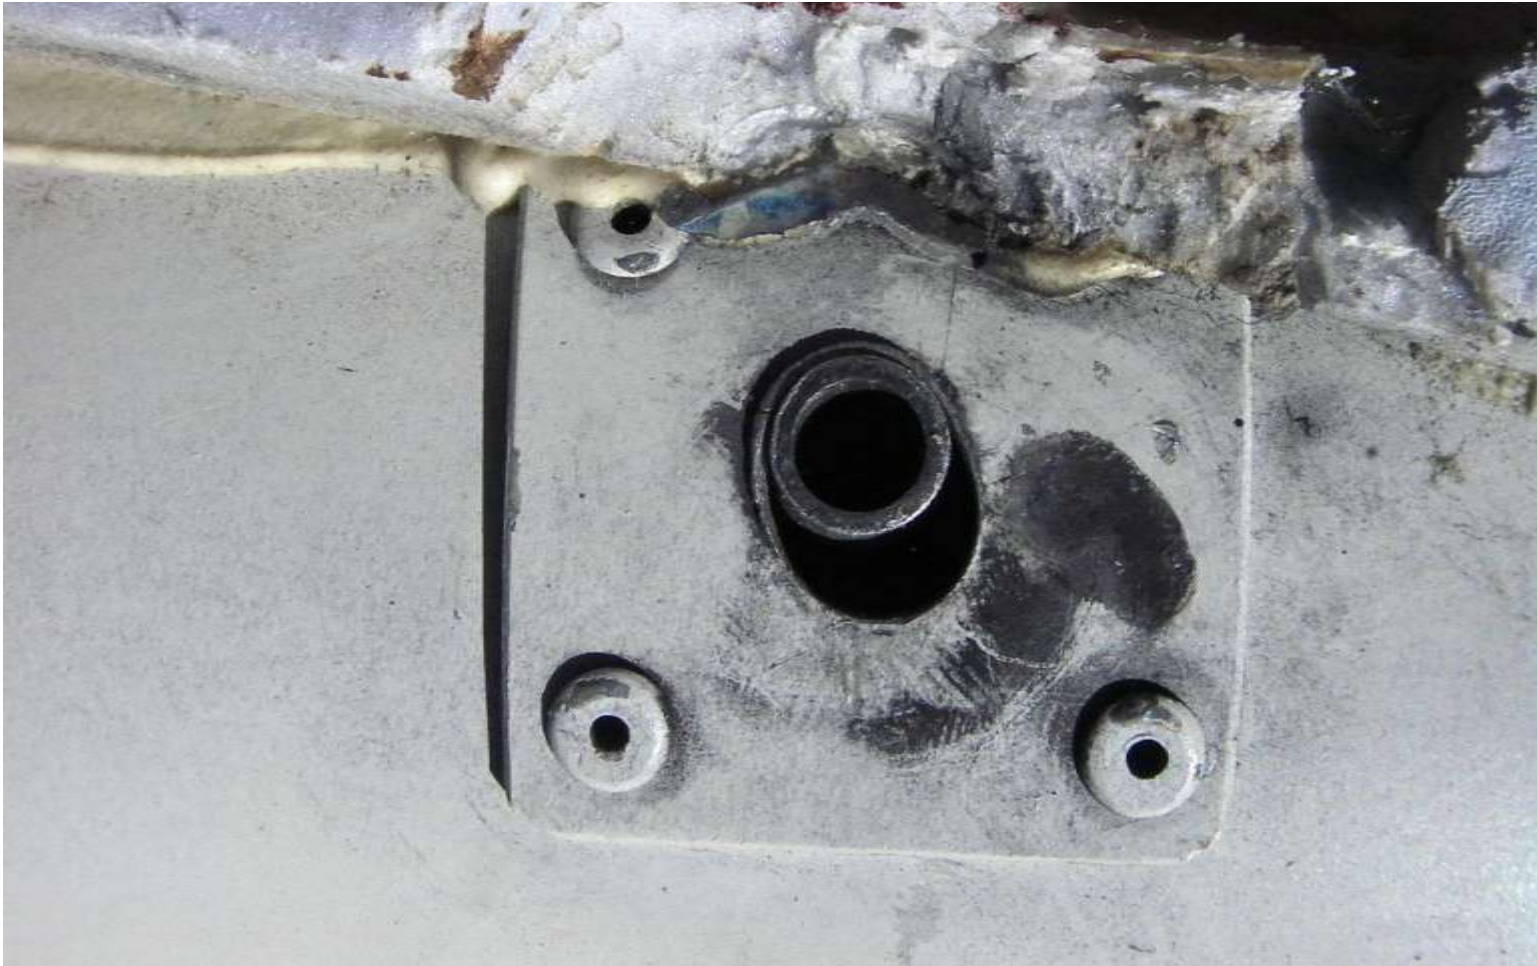
Photo 6 Port side of boom at rear hanger attachment, showing at least 4.5mm ovalised wear (in 2mm thick port backing plate)

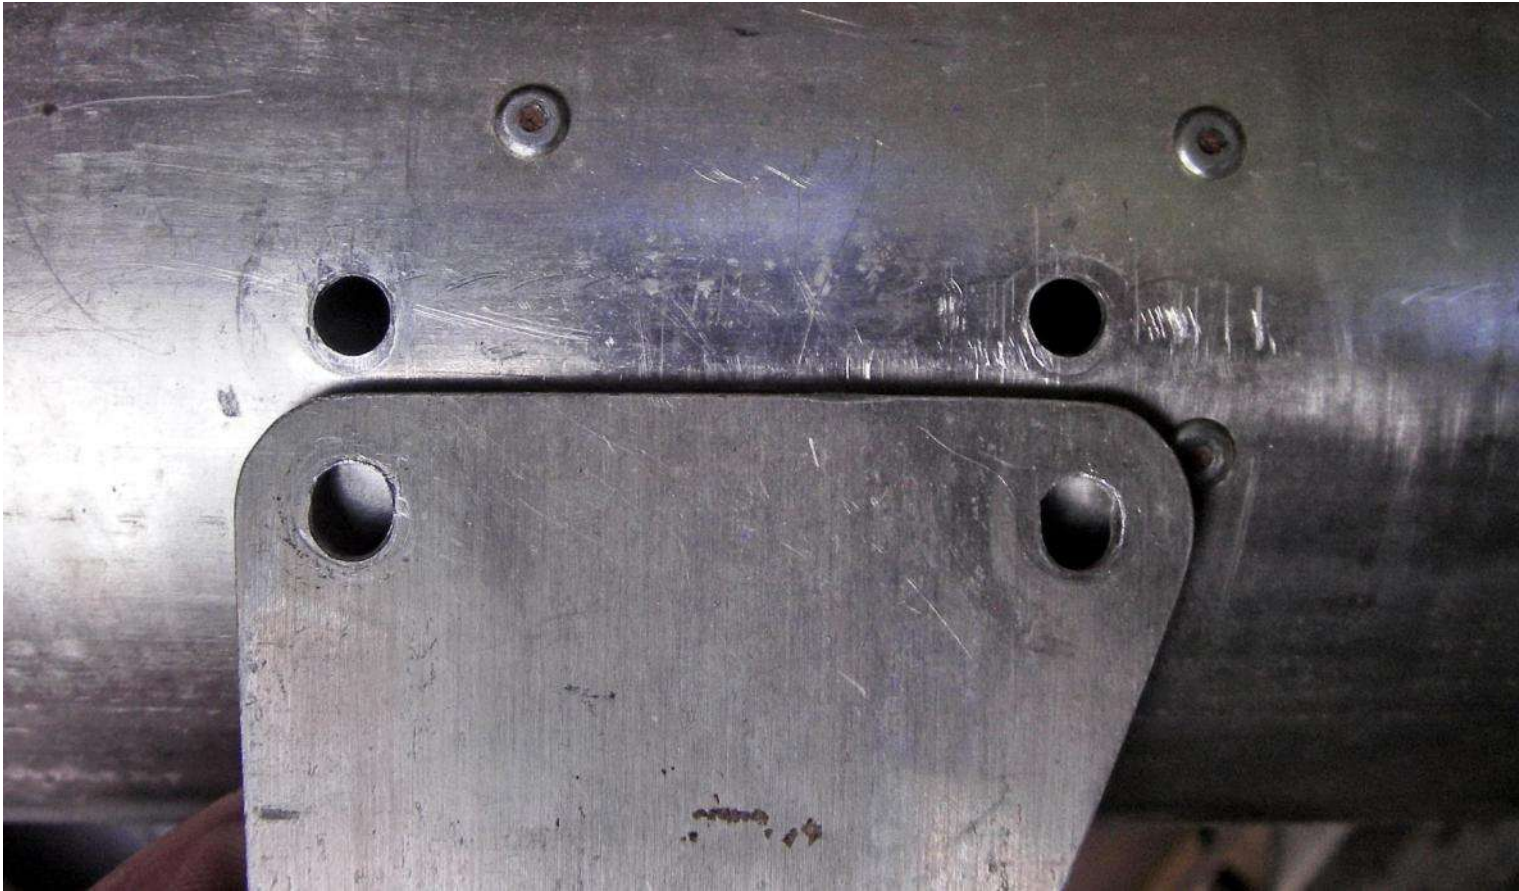
The mounting holes in the front alloy hanger brackets (F153) were worn. [see Photo 7]
The port side had very ovalised holes with 1.5mm slop.

Photo 7 Front hanger bracket (port side), showing at least 1.5mm ovalised wear in mounting holes
